Bridgestone Tyre Debris Study Report 2015-17

Report No.	16-00061
Date	February 2018
Author	P. Moulding
Contributors	G. Powell K. Hales S. Finn C. Scott

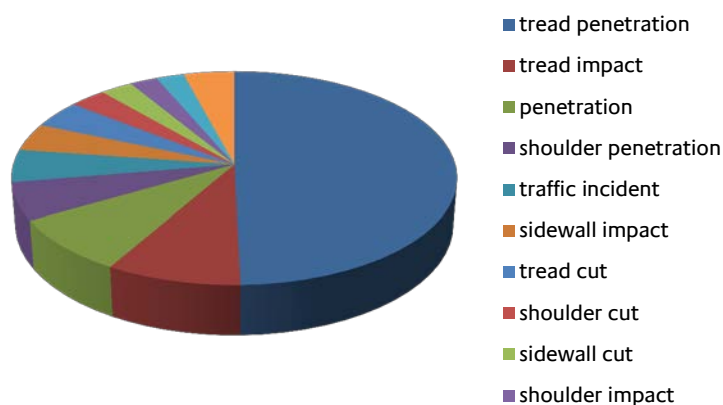
Road Hazard Categorisation (passenger car):

For the passenger car tyre samples, road hazards account for 47% of problems.

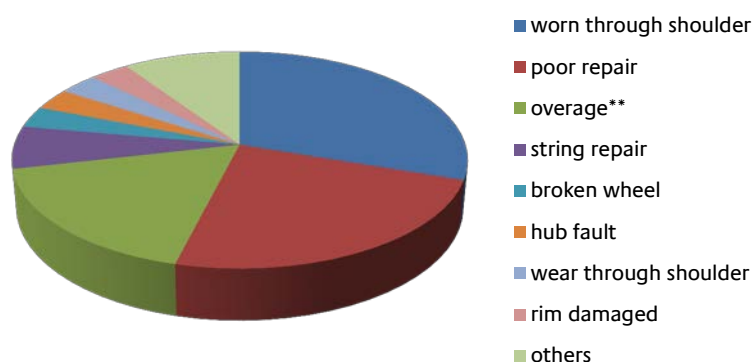
Maintenance Issues Categorisation (passenger car) :

Incorrect vehicle alignment and poor repairs on passenger car tyres are surprisingly common. i.e : Four tyres being found with string repairs, and a temporary spare run to destruction indicates vehicles are being run in an unroadworthy condition, or without consideration of the limits of such temporary remedies.

**'Overage' refers to tyres which have suffered from age-related perishing (cracking).

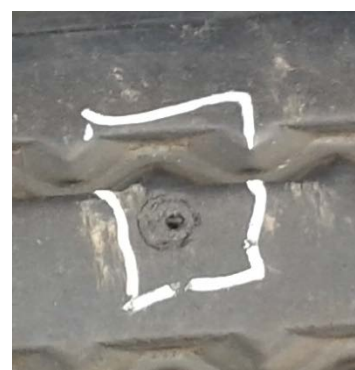
However it would be reasonable to assume many of the tyres which had suffered from penetrations had been operating penetrated for some time. The penetrating object can often partially plug the hole and be carried for some time if not detected, resulting in a slow deflation.

Marks such as these indicate the object has been in the tyre for some time prior to failure =>
