Bridgestone Tyre Debris Study Report 2015-17

Report No.	16-00061
Date	February 2018
Author	P. Moulding
Contributors	G. Powell K. Hales S. Finn C. Scott

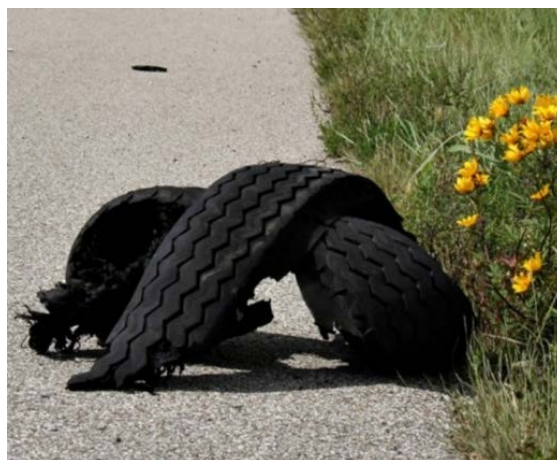
The majority of the samples in the skips were complete tread strips. Incomplete tread strips (fragments) were the second most frequent found.

It is probable that tyres which are not destroyed (whole tyres, wheel and tyre, casing) are taken away on the recovery vehicle when the tyre is changed. As Truck & Bus Radial casings potentially have a retread value, there is a likelihood some of these may have been removed for casing sale. Also, tyres which have been destroyed during a traffic incident may have been removed by the emergency services.

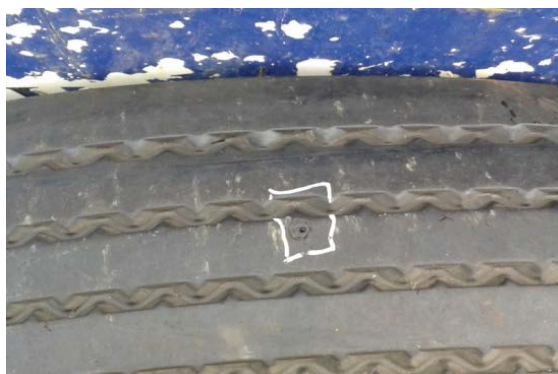
Tyres damaged by road hazards accounted for over 50% of the tyres inspected.

Where a cause could not be definitively ascertained, we erred on the side of 'indeterminate' rather than risk contaminating the data. For example, a tyre showing runflat damage but where we could not categorically state whether the damage was caused before or after the tyre failure was classed as 'Indeterminate'.

'Over-deflection' accounted for all tyres which had failed through runflat damage from poor pressure maintenance, but not those where a tread penetration or other damage has been detected. In our consideration, such cases could have also been classified as poor maintenance.

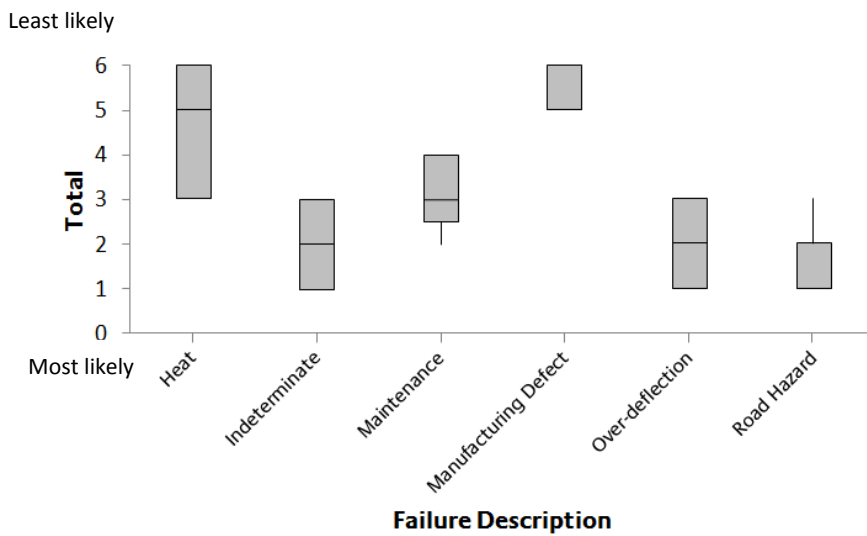
Ranking of failure description:

This box plot visually shows the data from the 'Sample Condition and Failure mode' table on the previous page. It shows that Road Hazard has the greatest likelihood of being the reason for failure, followed by indeterminate, over-deflection, maintenance, excessive heat and then manufacturing defect.

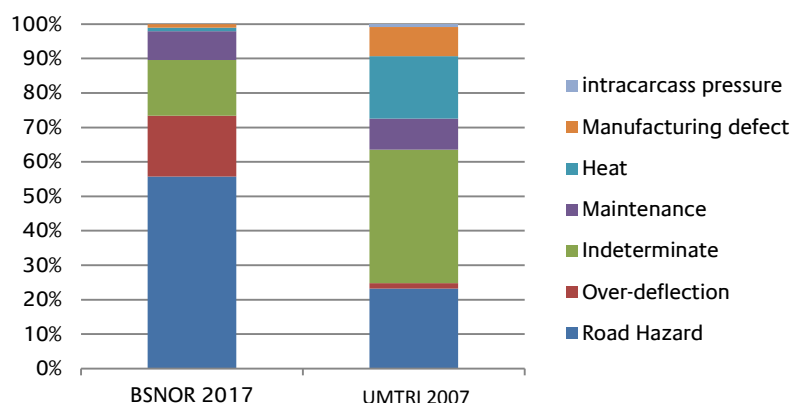
Comparison of all results:

If we remove the indeterminate adjudications from the results, we can see both studies agree that most tyre debris originates from a road hazard (BSNOR=66%, UMTRI=39%)

It may be that roads in USA are cleared of road hazards more frequently than in UK, which is why they have experienced less instances of this failure type. With regard to damage from road features (i.e. potholes, raised ironworkings etc.): for 2015-2016 period, World Economic Forum rated United Kingdom 29th in world for road quality (scoring 5.2/7) and United States 14th in world (scoring 5.7/7). So this may partly explain the greater incidents of road damage noted in UK (*The Global Competitiveness Report 2015–2016 – World Economic Forum*). We believe the USA has straighter roads and lower traffic density than the UK, which would also help prevent road hazard damage, but no data could be found to confirm this.

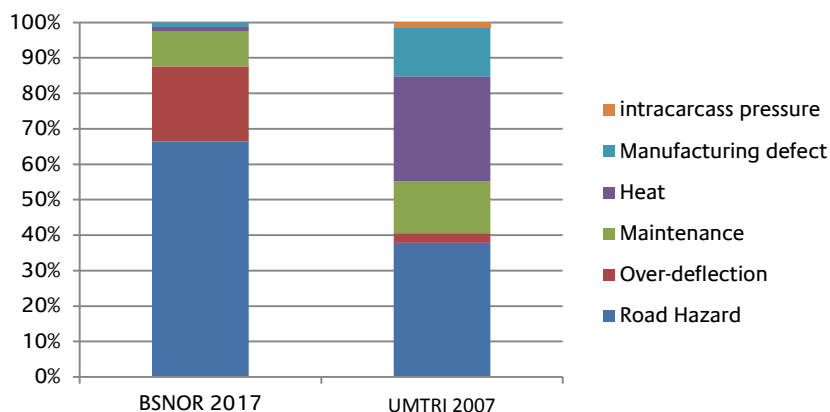
Comparison of results w/o indeterminate:

The UMTRI study found a much higher incidence of manufacturing defects than BSNOR (BSNOR=1%, UMTRI=14%). All of the manufacturing defects found in UMTRI relate to retreaded tyres, and are stated as being mostly ‘casing selection and repair, or tread rubber application issues’. It is a trend in US that smaller retreading shops are closing while total output remains the same (*TRIB 2012*). We would expect that the smaller retreading shops would have less quality control processes than a larger retreader, so that should correspond to a reduction in manufacturing defects over time.

There have been improvements in non-destructive testing since 2007, particularly with the implementation of shearography machines. So if the study was repeated, we would expect a reduction in manufacturing defects in the USA.
